BP OIL SPILL RESPONSE OPERATIONS DEEPWATER HORIZON OIL RIG GULF OF MEXICO VENICE, LOUISIANA

(PART 1 of 2)

Prepared by Oil Spill Control Services Inc. Richmond Hill, Ontario

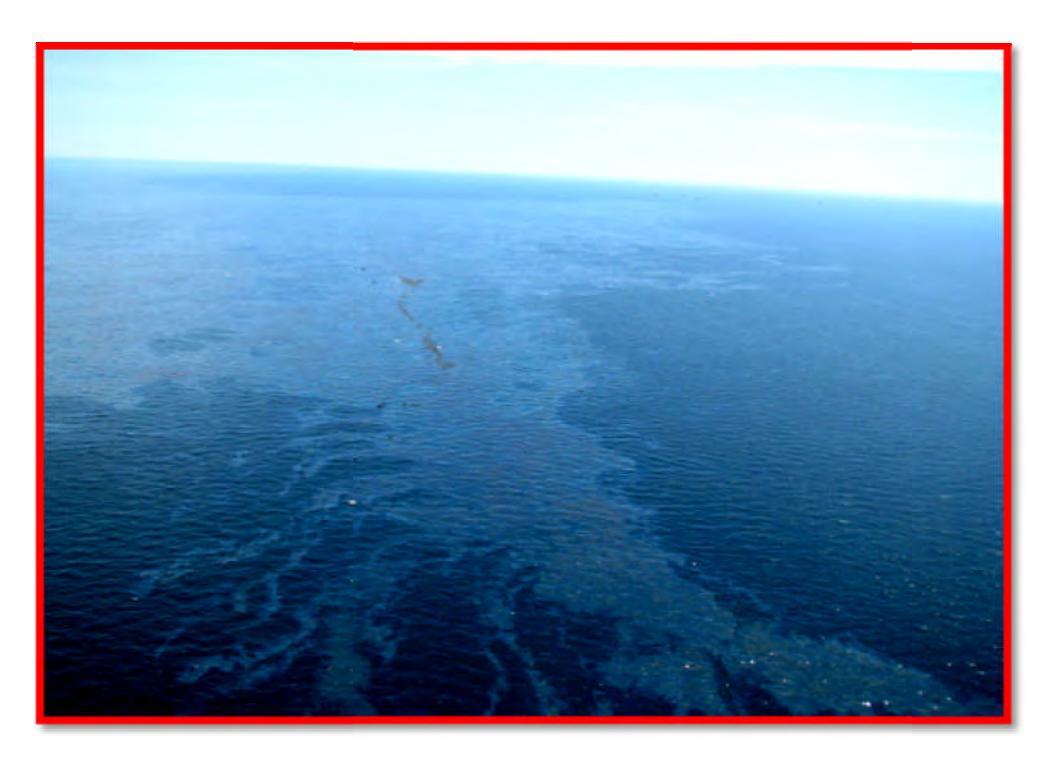
1 – As a result of the failure of the rig, the drill pipe (riser) on the ocean floor separated from the Blowout Preventer (BOP) and oil starting to spill into the Gulf of Mexico

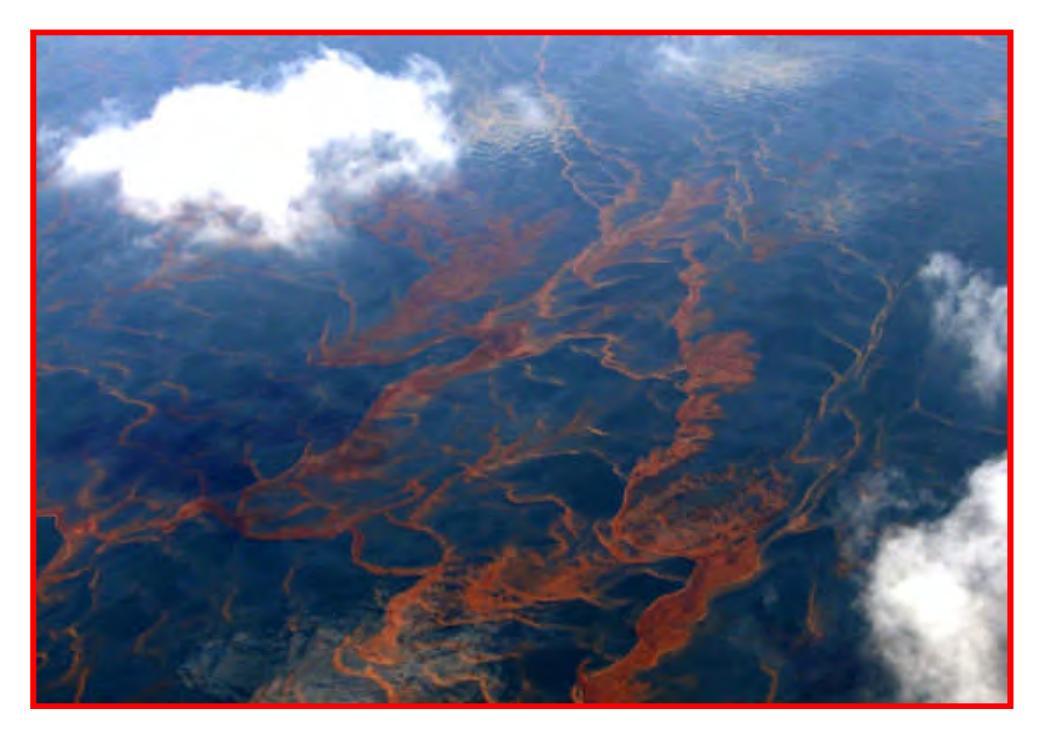
2- Chemical dispersants were used to break-up the heavy oil slick on the water. This aerial view of the dispersed oil covers an area of approximately 2 miles long and 4 miles wide.

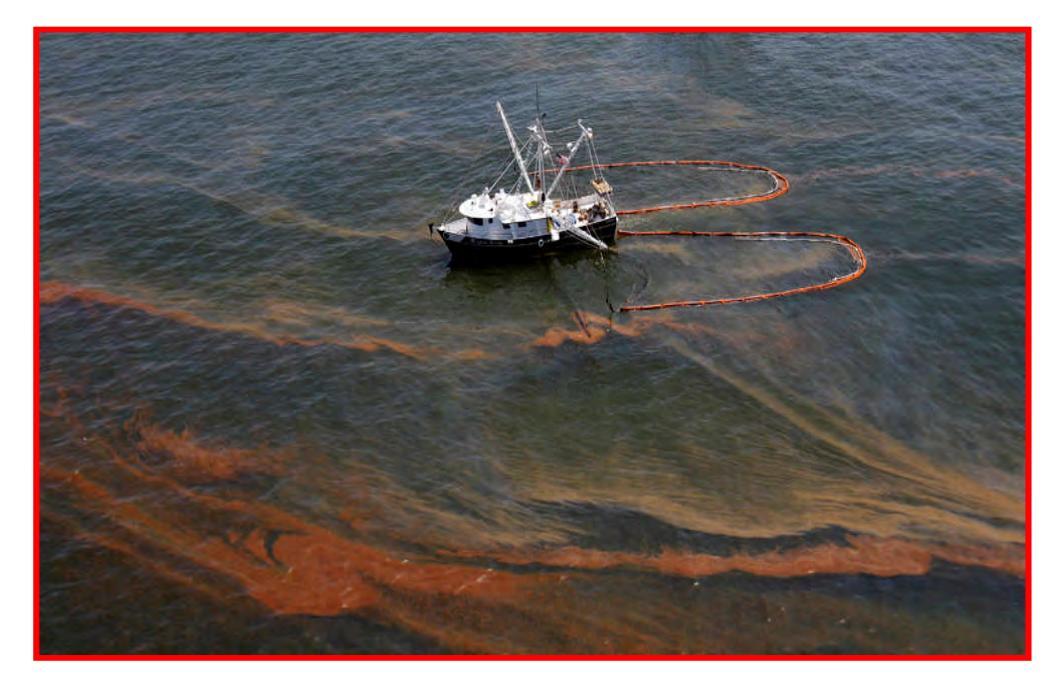
3 – In an effort to contain the oil off-shore, fishing boats were used to deploy containment booms on the water.

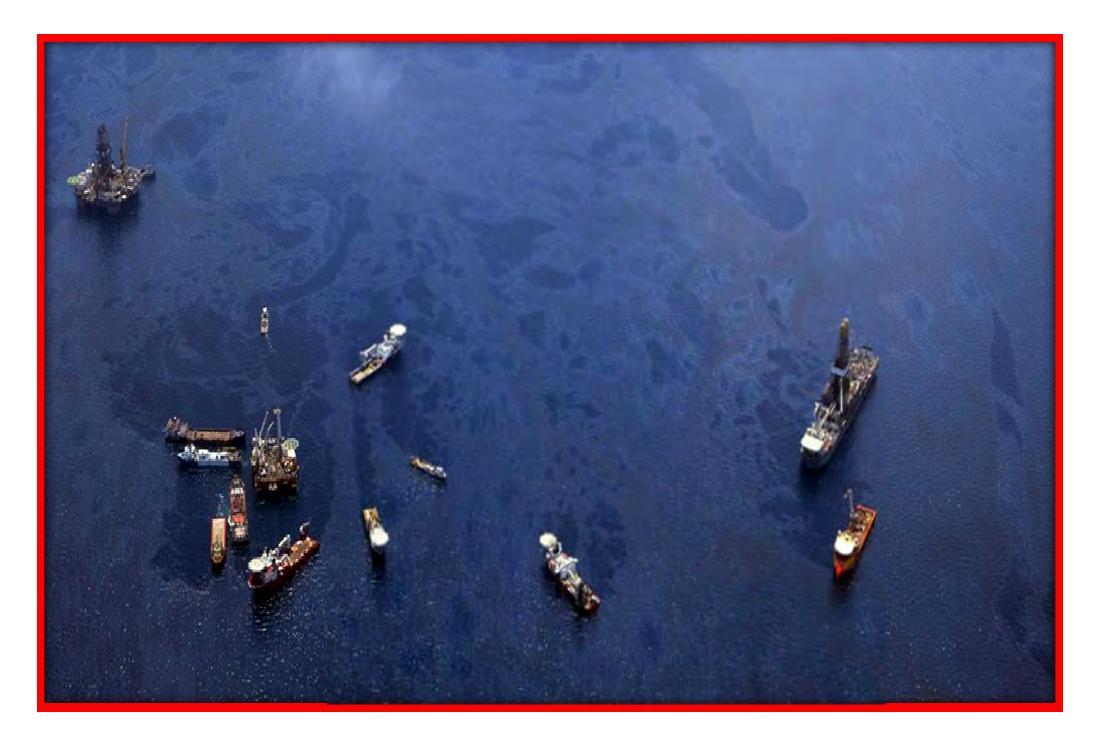
4 – 2 "relief wells" are being drilled at the site of the submerged Deepwater Horizon rig. Upon completion of the relief well, drilling mud and cement will be pumped into the damaged riser of the BOP in an effort to create a "dynamic kill" of the well bore. The well bore extends an additional 8,500 feet below the ocean floor. (Photo courtesy MSNBC)

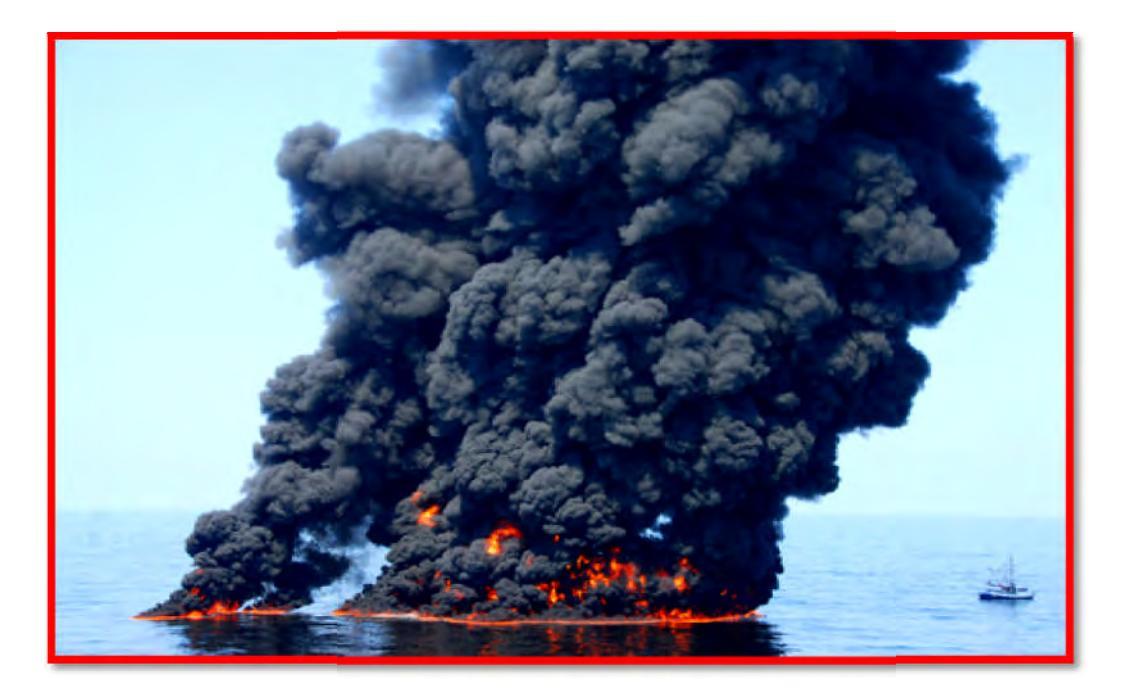
5 – As the oil slick continued to grow, a series of test burns were conducted in the Gulf of Mexico to reduce the volume of crude oil on the water.

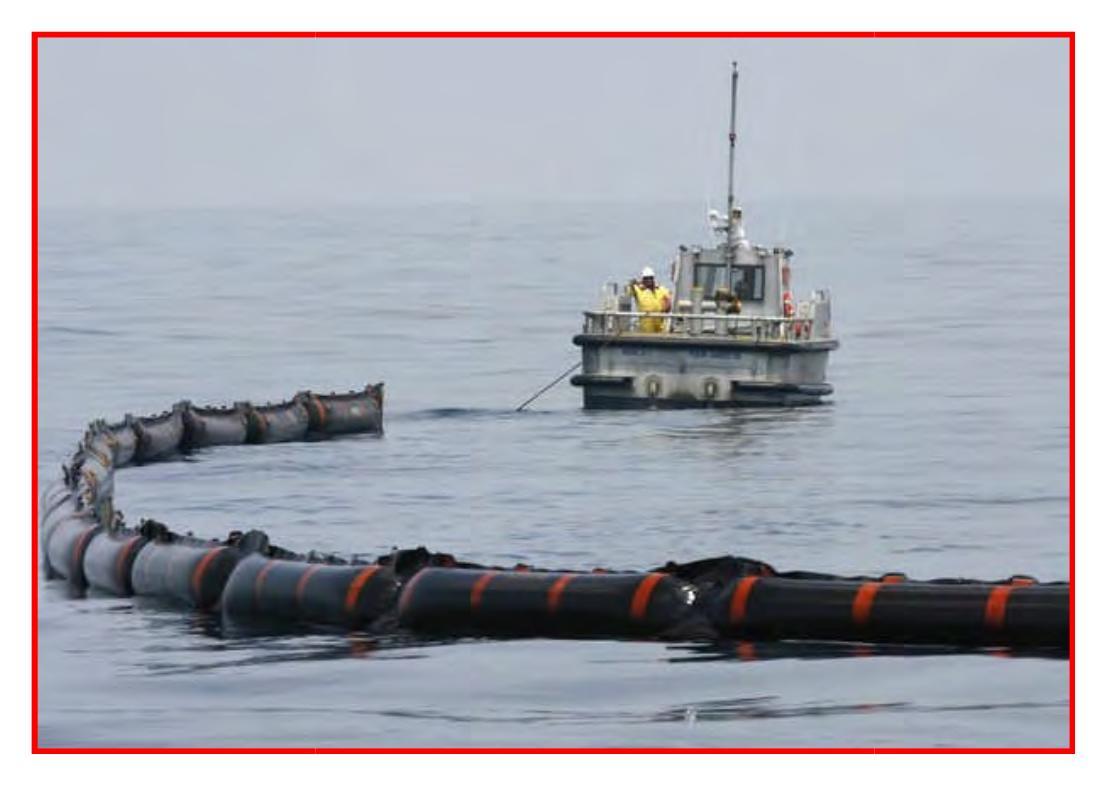
7 – Crews continued to deploy additional containment booms for the large scale off-shore oil recovery operations in the vicinity of the rig failure.

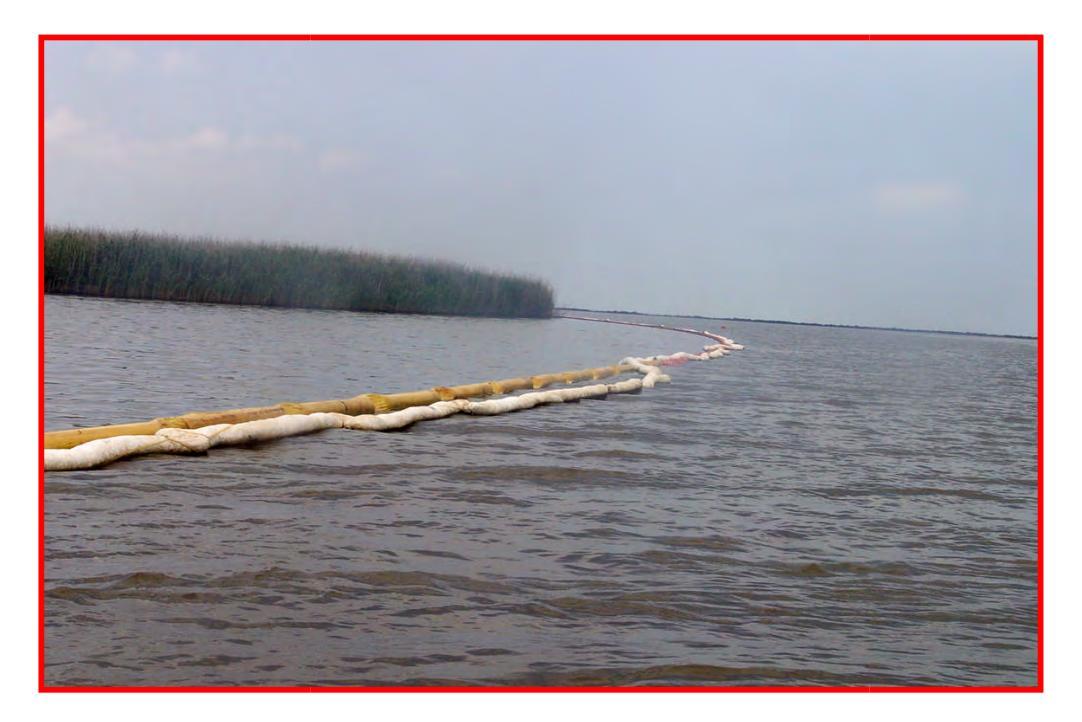
8-Miles of containment booms (yellow) and sorbent booms (white) were placed around ecologically sensitive areas (marshlands, coastal estuaries etc.) to deflect the crude oil away from these areas

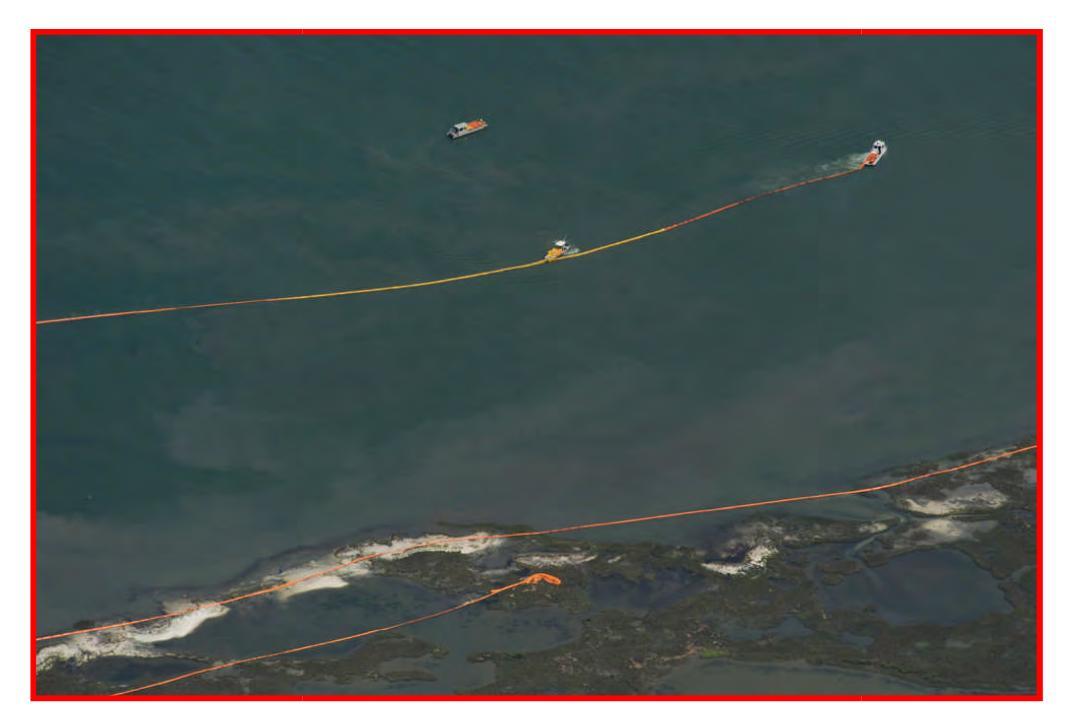
9 - Protection booms (red and yellow booms) were placed along the Chandeleur Islands (along the Louisiana coast) to prevent the oil from impacting these barrier islands. (Courtesy Reuters News Agency)

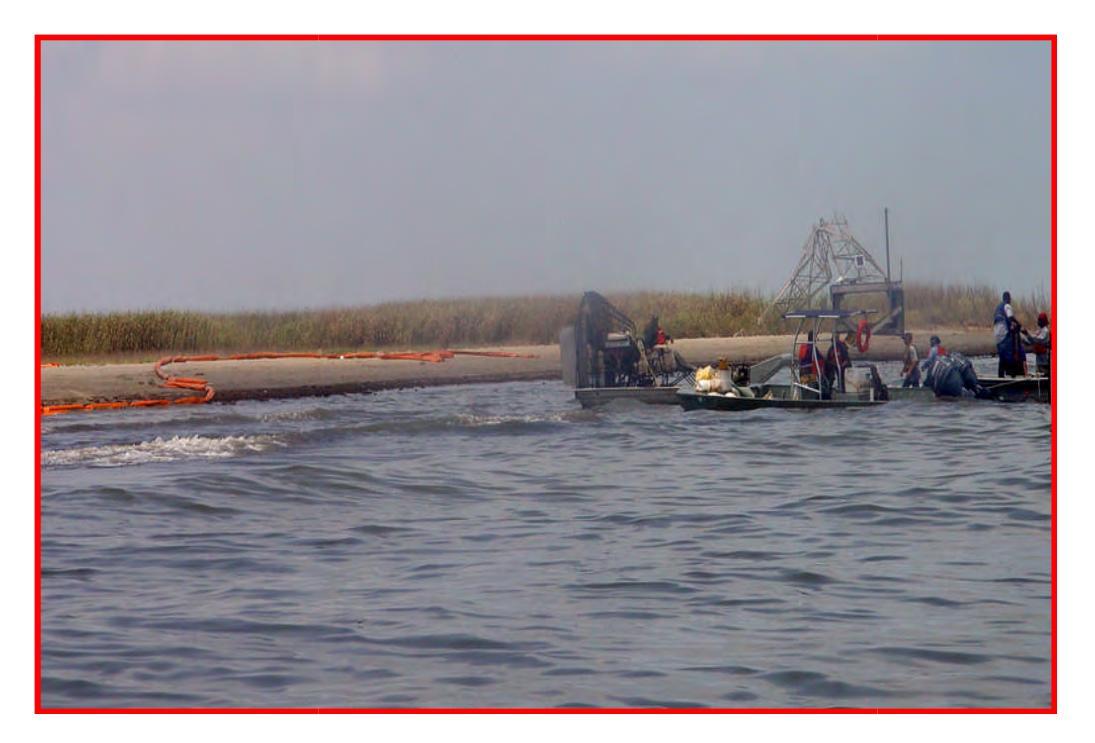
10 - Due to the heavy wind and wave conditions, the containment booms washed up on shore. Due to the shallow waters, air boats were used to recover the beached booms.

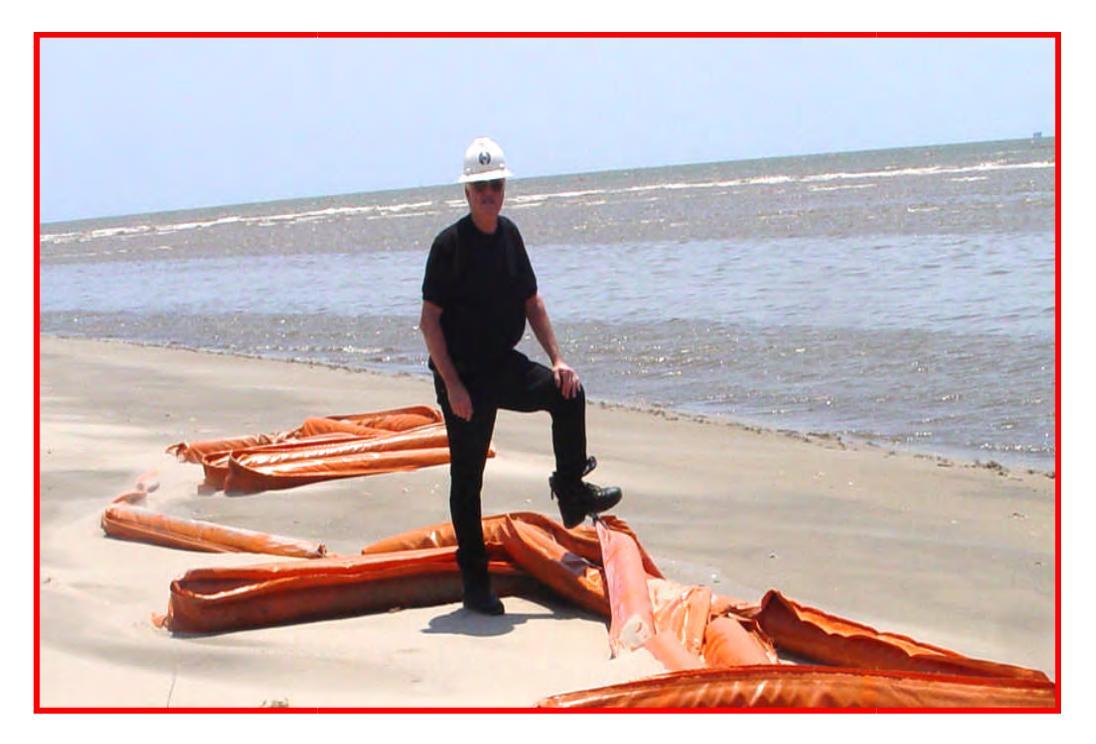
11 - The containment booms in other areas along the coast also washed up on shore and they had to be placed back in the water several times.

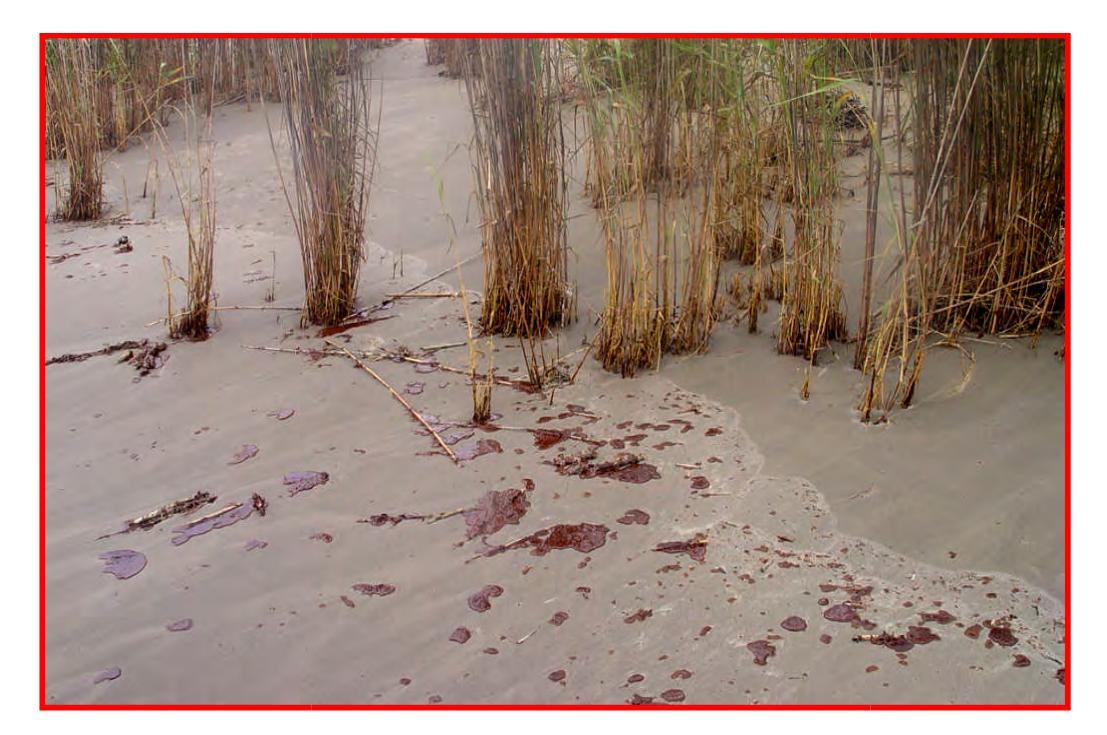
12 –Heavy crude oil deposits (brown tar balls on the sand) started washing up along the Louisiana coast 3 weeks after the spill began. The oil had traveled over 50 miles from the damaged oil rig to this location near Venice, Louisiana. The tar balls represent the *LEADING EDGE* of the oil slick.

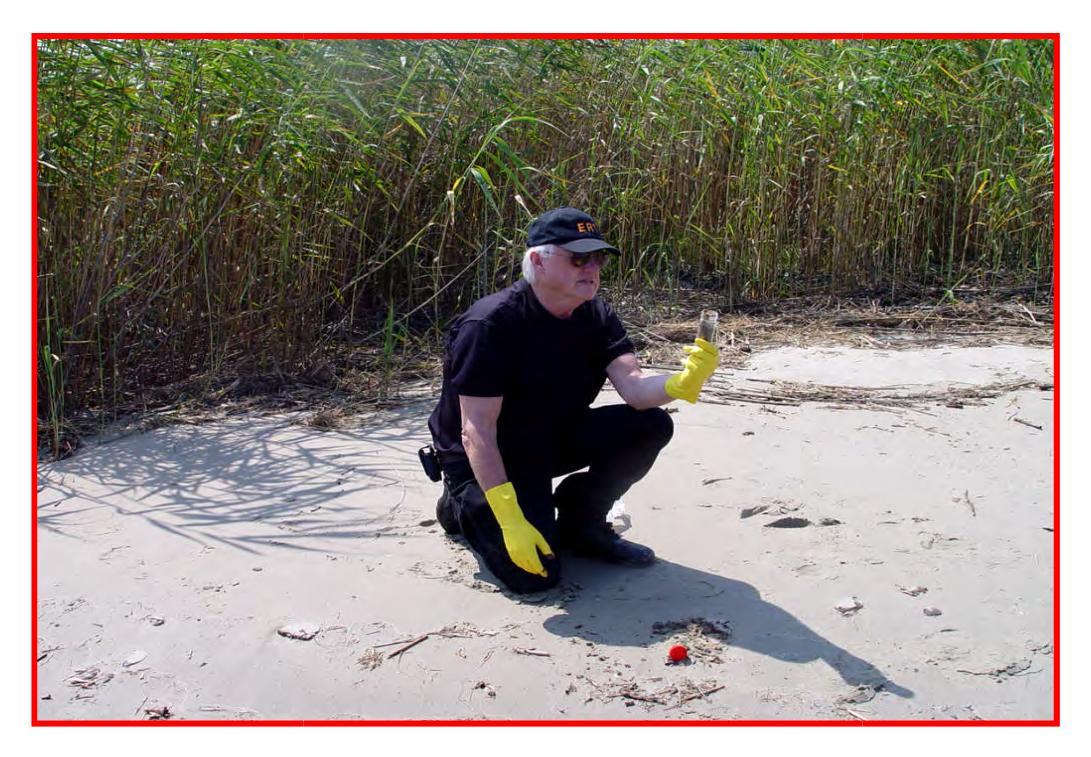
13– SCAT teams (Shoreline Clean-Up Advisory Teams) were established along the coast lines to assess the environmental impacts from the oil washing up on shore. At South Pass (near the mouth of the Mississippi River) heavy crude oil deposits were discovered under the sand.

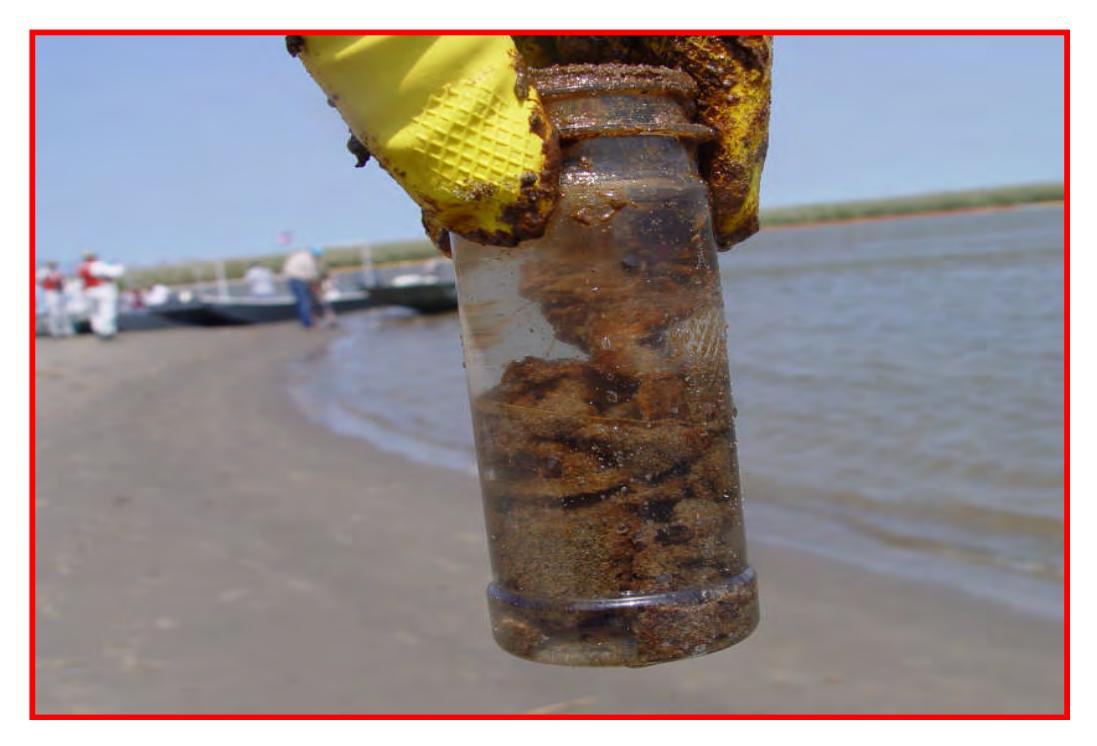
14 – A close inspection of the sand sample confirmed heavy crude oil was mixed in with the sand. The crude oil along the shoreline was very "sticky" and quickly attached to anything it contacts.

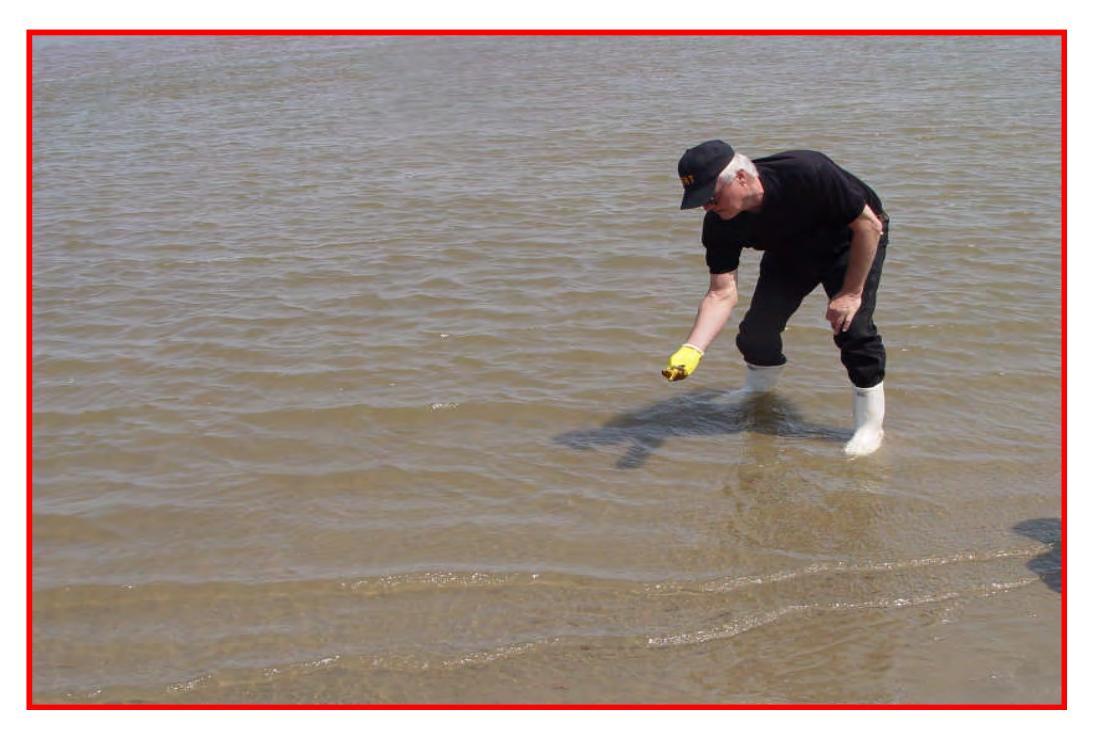
15 – The leading edge of the oil slick was observed washing up on several shorelines from under the water. (dispersed oil does not float)

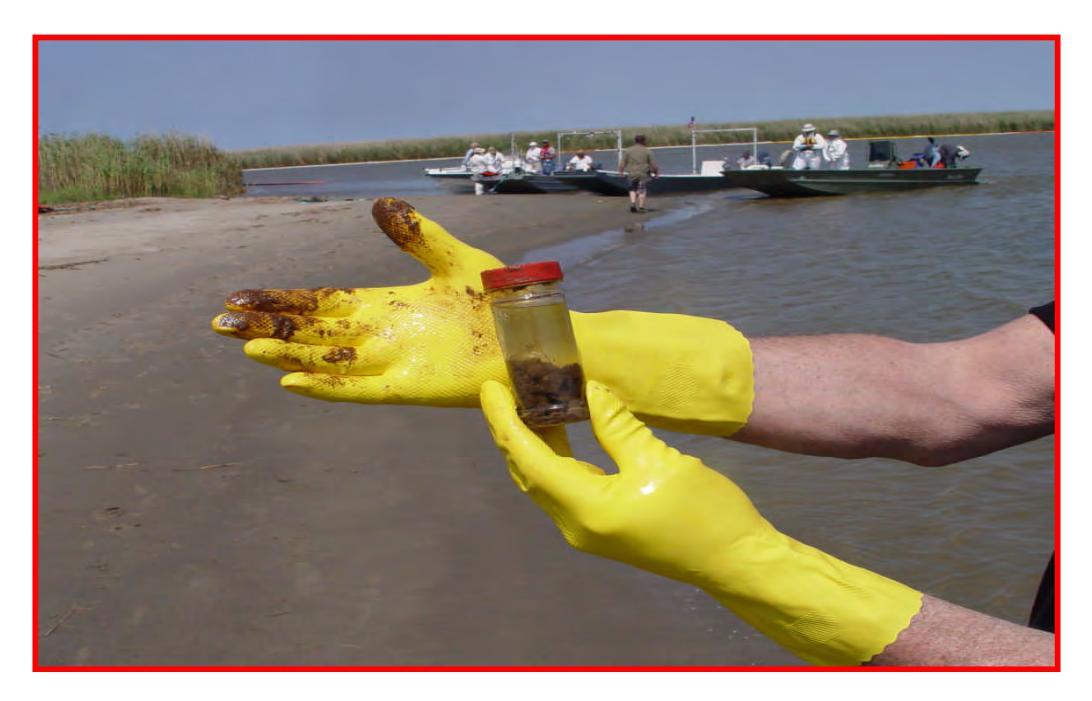
16 – Samples of the dispersed oil were collected from under the water. The oil sank to the bottom of the sample bottle. NOTE: Oil will float on water unless it has been impacted with chemical dispersants. Dispersed oil will sink below the surface of the water, as can be seen in the sample bottle.

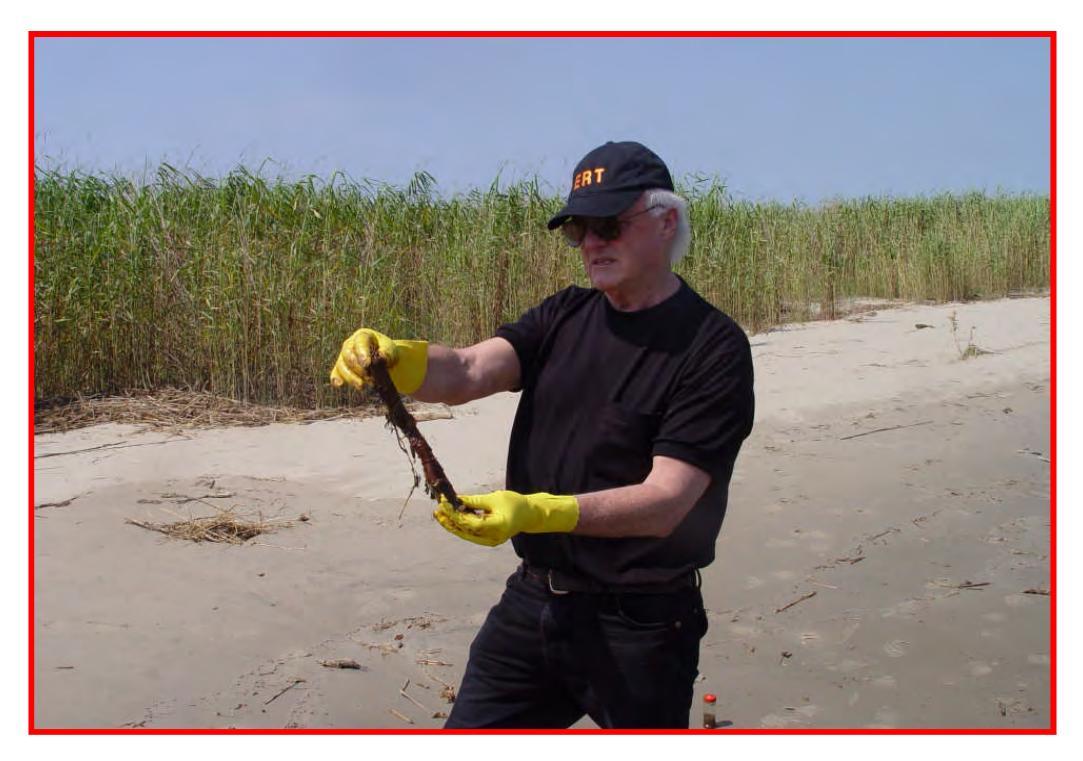
17 - Samples of oil contaminated vegetation were also collected to determine the extent of the environmental damage to the marshes and the wetlands.

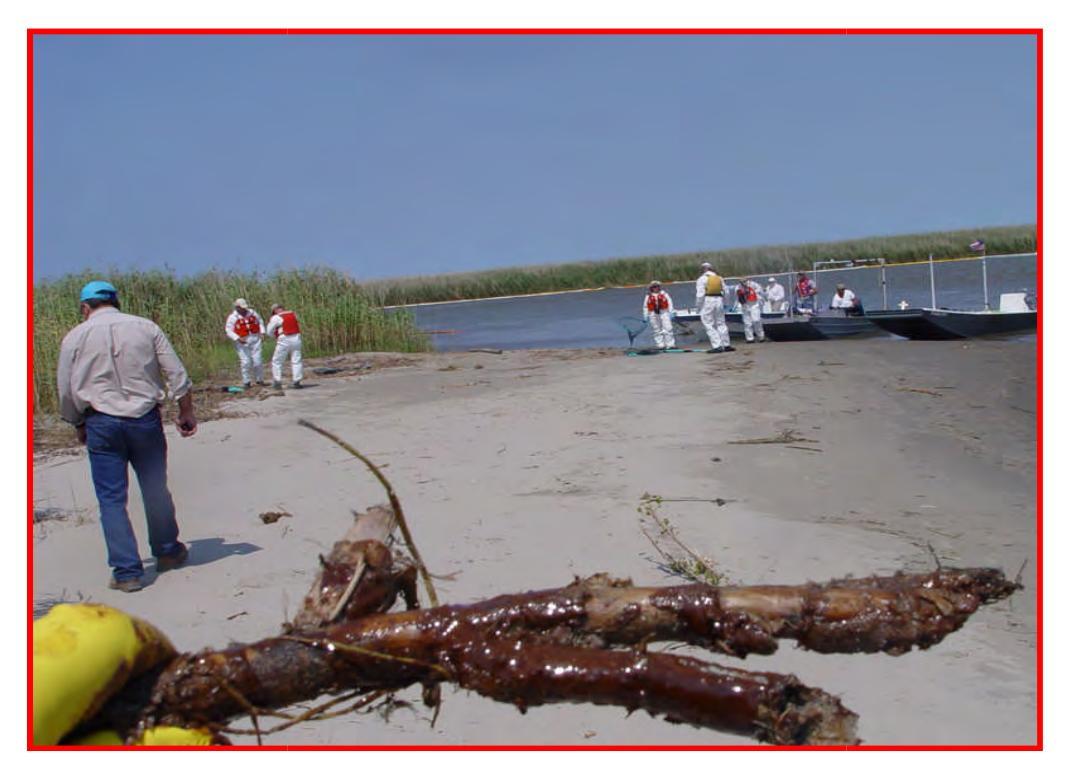
18 –Visual observations confirmed the near-shore vegetation was impacted by the crude oil spill.

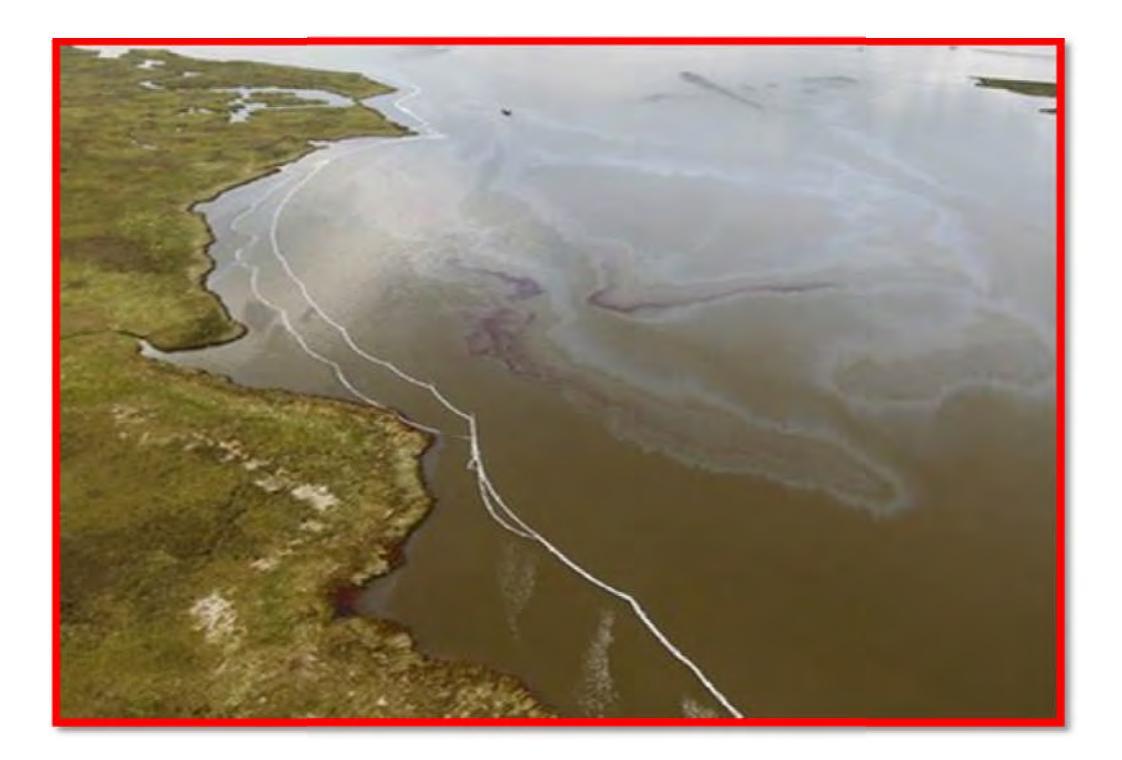
19 –Crude oil entering Barataria Bay, Louisiana. Booms (white) were placed along the shoreline to protect the wildlife. Barataria Bay has been designated an estuary of national significance by the Environmental Protection Agency National Estuary Program. The bay is characterized by swamp forests and marshes which provide a nursery and breeding ground for migratory birds and a variety of recreationally and commercial important species, including alligators, finfish, shellfish, songbirds, ducks and geese.
